**Work-related fatalities
Associated with design
Issues involving machinery and
fixed plant in
Australia, 1989 to 1992**

September 2000

**Information from
the second work-related fatalities study,
1989 to 1992**

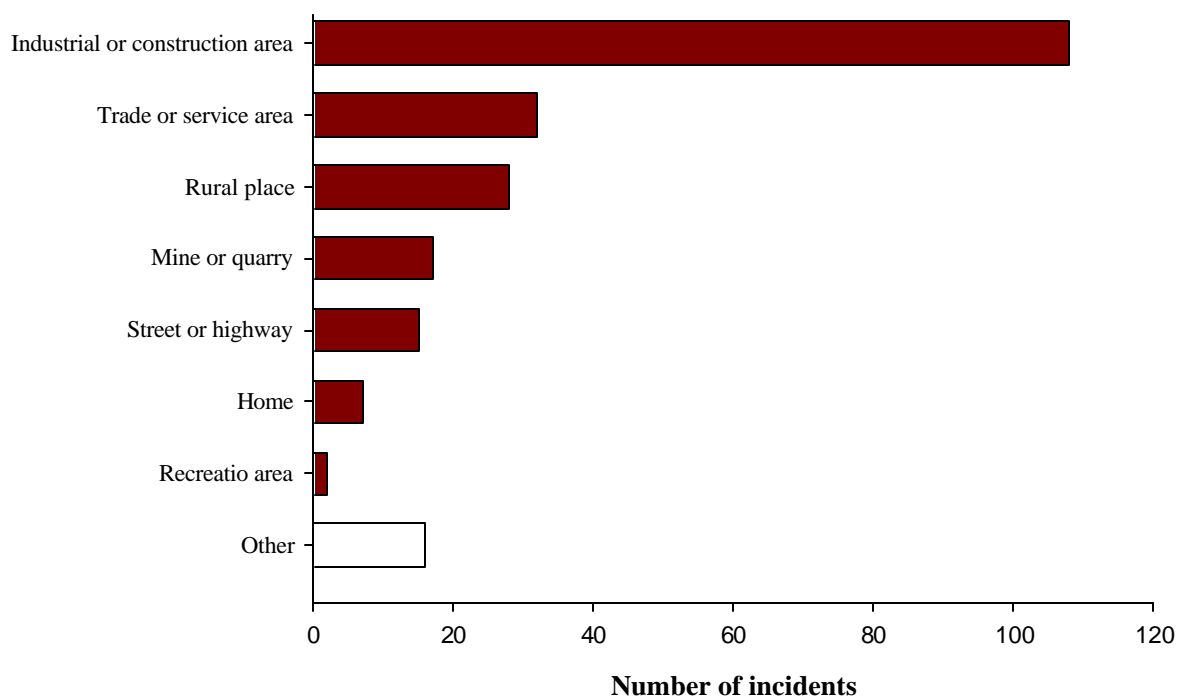
**Figure 1 Place of fatal incident where working persons and bystanders were fatally injured from machinery and fixed plant.
Number — Australia, 1989 to 1992**

Of the 225 fatal incidents, approximately half occurred in industrial or construction areas (Figure 1).

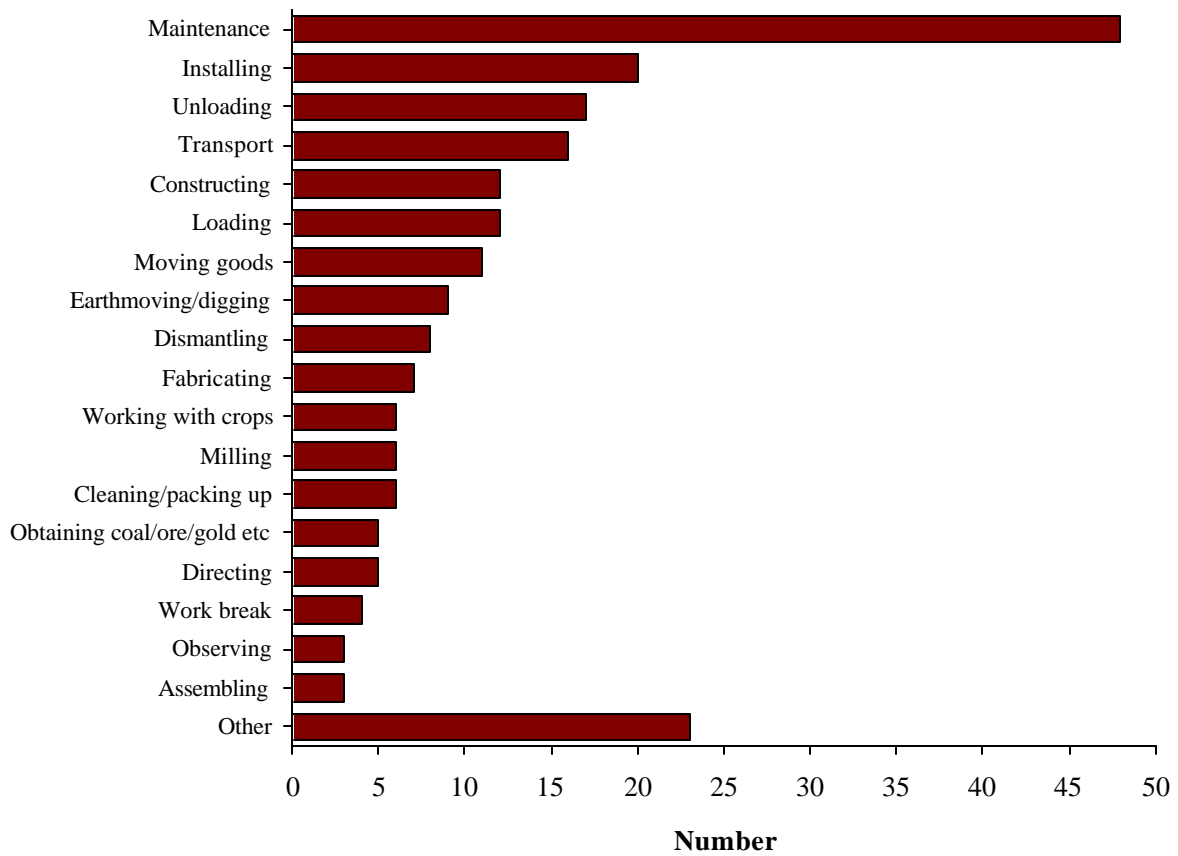
Figure 2 Activity at time of incident for working persons fatally injured in incidents involving machinery and fixed plant.
Number — Australia, 1989 to 1992

The most frequent single activity being conducted by persons fatally injured while working at the time of the incident was maintenance. This was being performed by just over 20% of the working persons. The other common activities at the time of the incident included installing, transport and unloading (Figure 2).
