Guide to identifying and handling low density asbestos fibreboard

This Guide provides information about identifying, managing and handling low density asbestos fibreboard (LDB) in workplaces.

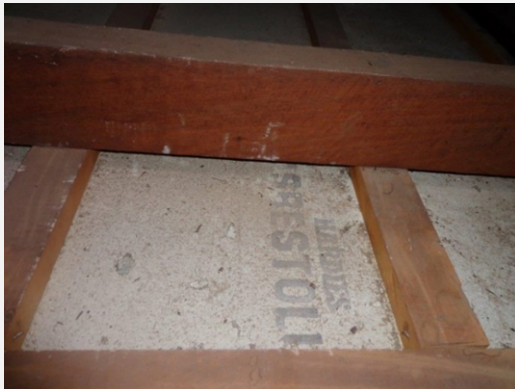
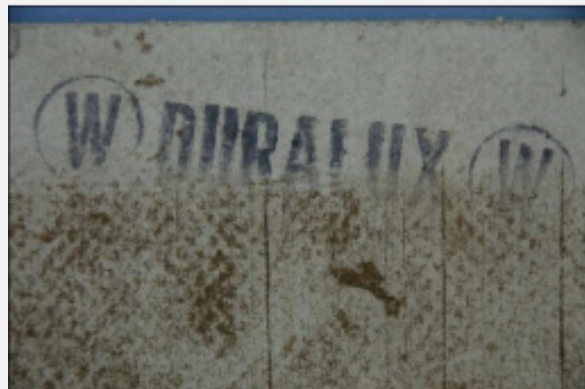
Label: LDB can be identified by looking at the rear side of the sheeting for the trade name Asbestolux (manufactured by Hardies) or Duralux (manufactured by Wunderlich), as shown in Figure 1.

Figure 1 Rear side of LDB sheets showing trade names

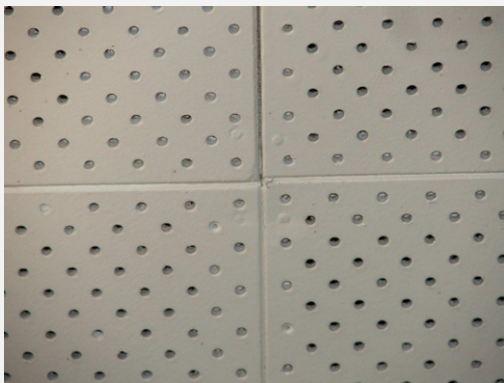
Ceiling sheets/tiles: LDB was often used as ceiling tiles/sheets and for acoustic purposes. LDB ceiling tiles were commonly perforated. Different patterns of perforated ceiling tiles were used with the difference being the number of holes per sheet as shown in Figure 2.

Figure 2 Front side of perforated LDB

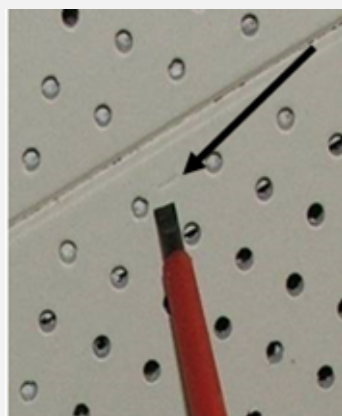
Hardness: LDB is softer than asbestos cement sheeting because calcium silicate plaster was used to bond the asbestos fibres instead of cement. When tapped, for example with a car key, LDB will produce a dead or dull sound, indicating a soft or low density product. Using hand pressure, the head of a screwdriver will easily dent the surface as shown in Figure 3.

Figure 3 Hand pressure from a screwdriver will dent the surface

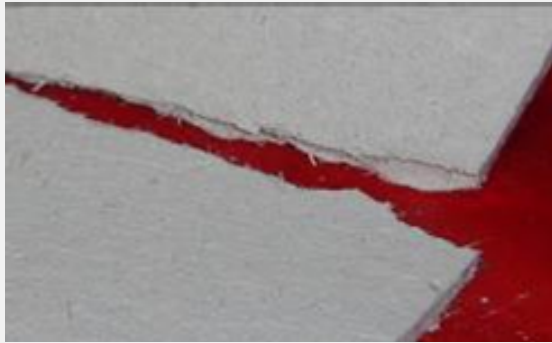
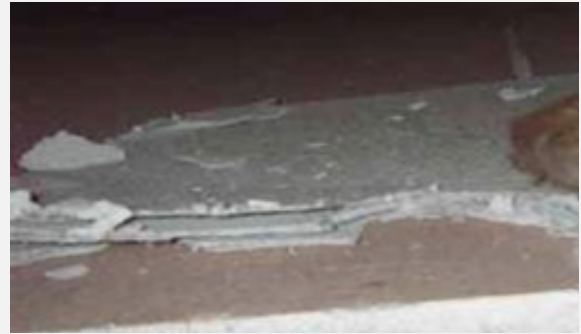
When broken the edges of LDB appear ragged or torn with no sharp edges as shown in Figure 4. You can see a high percentage of asbestos fibres—the entire surface of the broken sheeting looks furry or fibrous.

Figure 4 Ragged or torn edges of broken LDB

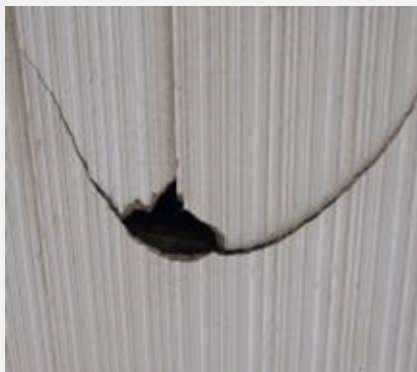
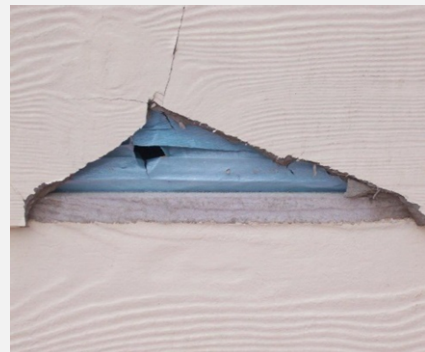
Asbestos cement sheeting breaks more cleanly as shown in Figure 5.

Figure 5 Examples of sharply broken edges on asbestos cement sheeting

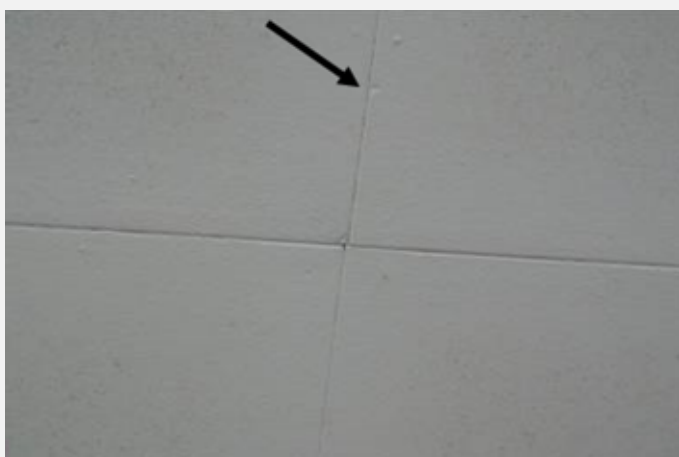
Finding fasteners: The heads of fasteners, nails and clouts are often embedded or partially embedded or recessed into the surface of LDB sheeting due to the softness of the sheeting as seen in Figure 6.

Figure 6 Recessed fastener heads in LDB

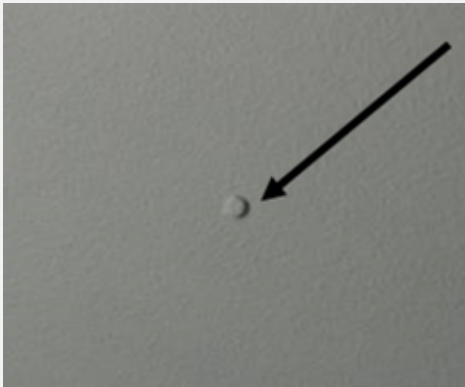
In contrast, the heads of the fasteners in asbestos cement sheeting do not sit level with the surface as seen in Figure 7.

Figure 7 Fastener in asbestos cement sheeting does not sit level with the surface

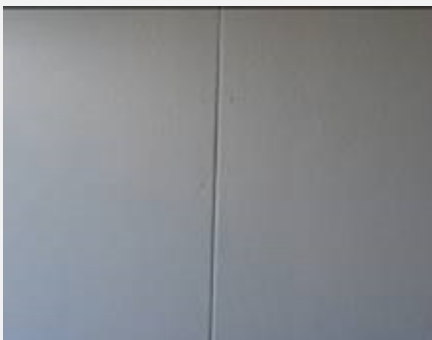
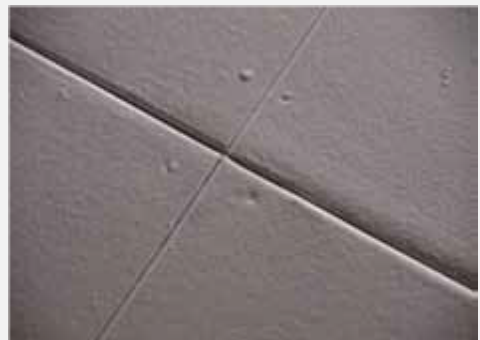
Joins between sheets: The edges of LDB products were often bevelled or slanted and hand planed so when fixed together with another sheet, a V-joint finish would be produced as shown in Figure 8.

Figure 8 Examples where fasteners are fixed into the LDB sheeting and the edges are bevelled or slanted

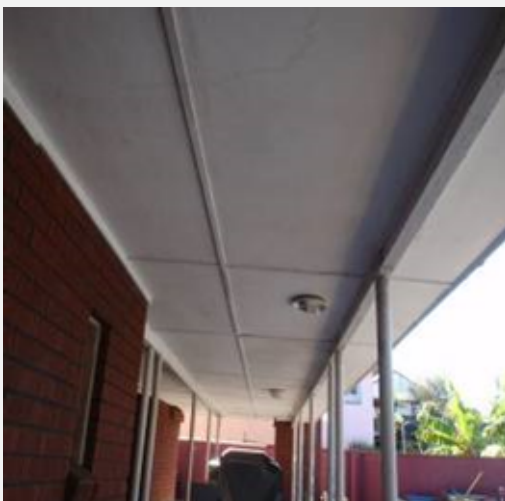
Joins of asbestos cement sheeting are usually covered over with flat or moulded timber cover strips. The sheets are sometimes joined with timber cover strips as shown in Figure 9.

Figure 9 Asbestos cement sheets joined with timber cover strips
